Manhole Inspection Summary

Manhole # S51C__034MH

Insp Date: **2/3/09 1:20 PM**

Location Address: **1 N LINWOOD-CURLEY-ALLEY**

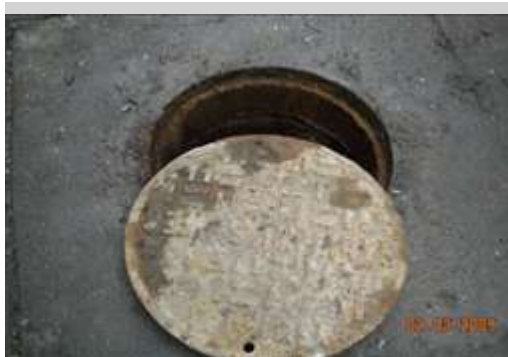
MISC.

REPLACED BROKEN COVER

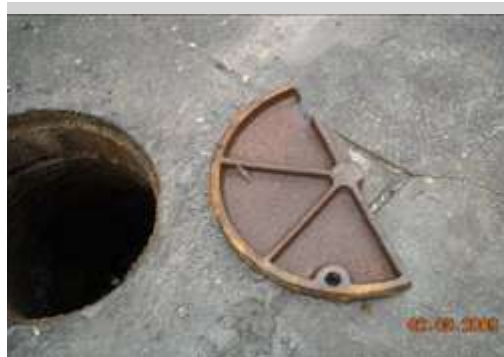
MISC.

BROKE COVER TO GAIN ACCESS

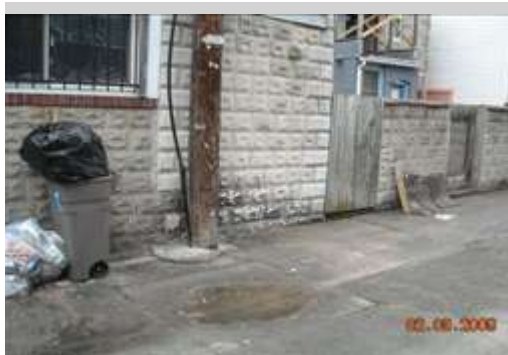
MISC.

☐ Prev. Rehab Weather: **Snow** Subject To Ponding: **Ponding**

MANHOLE SUBJECT TO PONDING

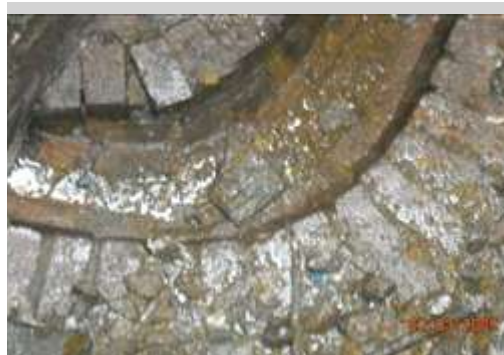
Defect 5

Condition: ☐ Sound ☐ Cracked ☐ Root Intrusion ☐ Deteriorated ☐ Leaks ☒ **Debris**

DEBRIS IN CHANNEL

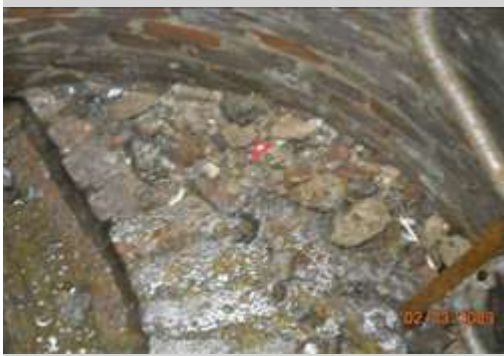
Defect 4

Condition: ☐ Sound ☐ Cracked ☐ Root Intrusion ☐ Deteriorated ☐ Leaks ☒ **Debris**

DEBRIS ON BENCH

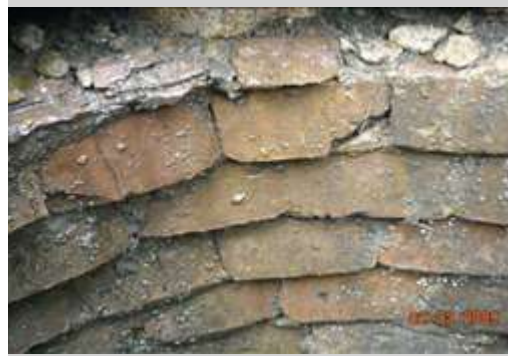
Defect 3

Condition: ☐ Sound ☒ **Cracked** ☐ Root Intrusion ☐ Loose Brick ☐ Deteriorated

CRACKED CORBEL BRICK

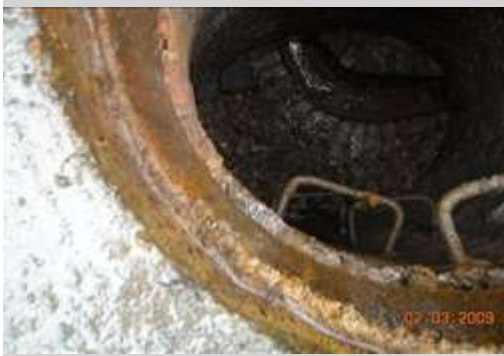
Defect 2

FRAME OFFSET

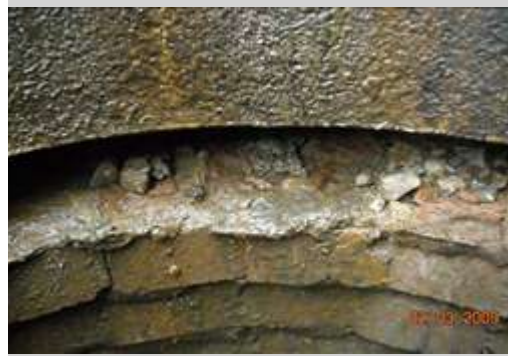
Defect 1

Condition: ☐ Sound ☐ Cracked ☐ Root Intrusion ☐ Loose Brick ☒ **Deteriorated**

DETERIORATED CHIMNEY

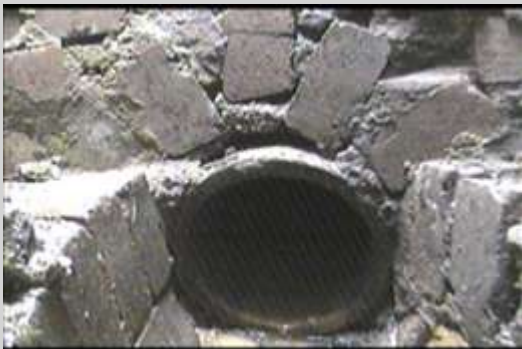
9 O'Clock Inflow

Pipe Height: **6** (in.) Rod and Bar (Angled)
Pipe Material: **Clay** ☐ Pipe Lined
Invert Depth: **7.32** (ft.) Flow Characteristics: **Slow**
Deposits: ☒ None ☐ Mud ☐ Sludge ☐ Debris ☐ Grease
Silt Depth: **0** (in.) Deposits Extent:
Infiltration: **None** Pipe Seal Cond: **Cracked**
